Test Report N° : 2011070401	
Place and date of issue:	Rimini, 04/07/2011
Customer:

dated 08/06/2011
Date test effected:	from 27/06/2011 till 04/07/2011
Purpose of test:	Salt spray test on nickel graphite silicon gaskets
Test site:	By Emc Test Technologies lab, Via Marechiese, 273 - Rimini
Equipment Id:	Nickel Graphite silicone Product number <u>SSP502;</u>

The test specimen also known as EUT (Equipment Under test) consist of Nickel Graphite silicone gasket.
Product number SSP502.

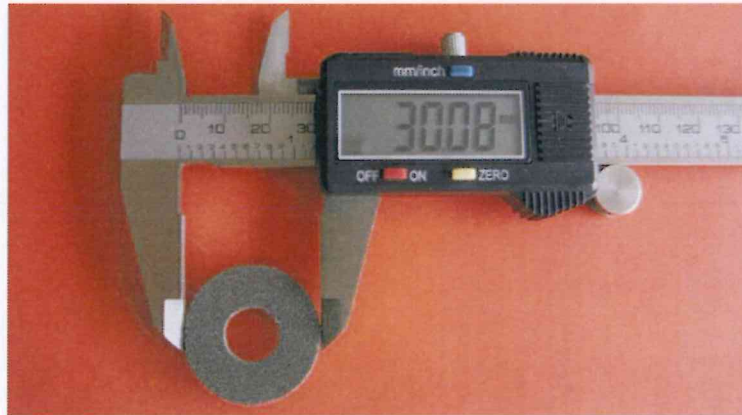
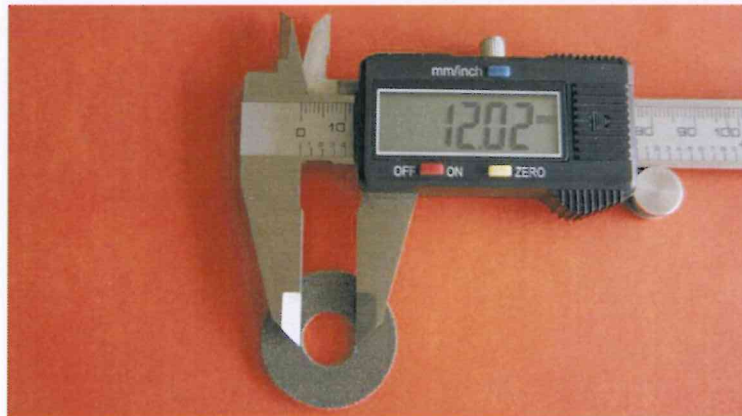
EUT - Dimensional details

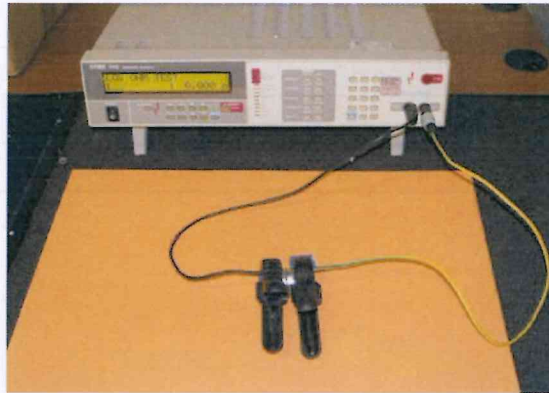
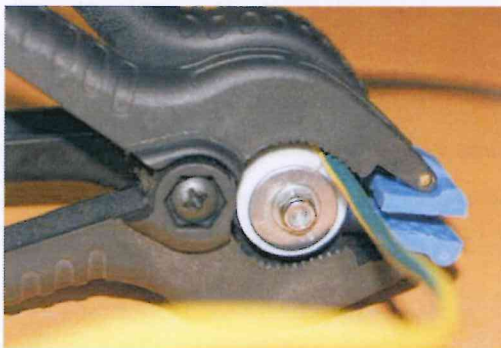
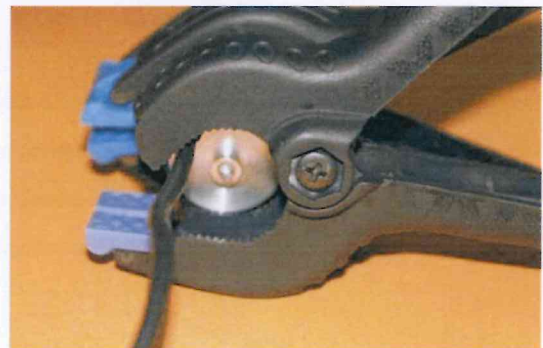
Before the test, initial transversal resistance values were acquired by means of a precision dielectric analyzer. The details of the test are shown in the pictures below.

Details during transversal resistance test before SST exposure

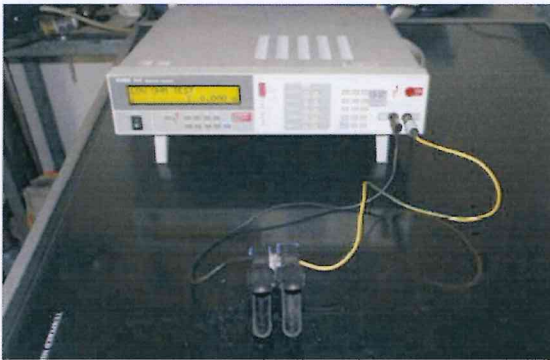
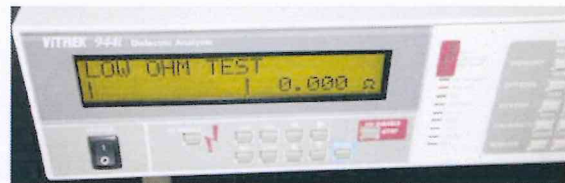
After 48 hours exposure, the test specimens were dried and the transversal electrical resistance measurements were recorded.

Pictures and results found during transversal resistance test after 48 hours SST.

Resistance before test	Salt spray test 48 h	Degradation 48 h	Salt spray test 96 h	Degradation 96 h
[mΩ]	[mΩ]	[%]	[mΩ]	[%]
0	0	0	0	0

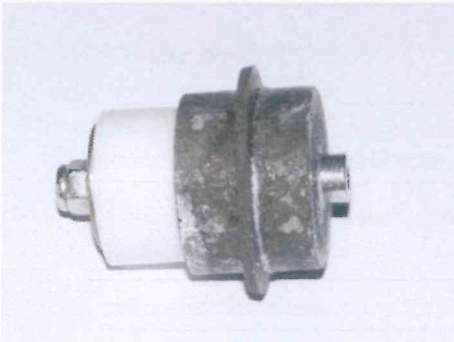
Oxidation of aluminum electrodes after 48 hours SST.

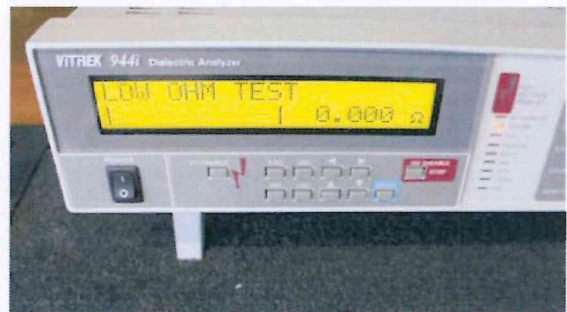
After 96 hours exposure, the test specimens were dried again and their transversal electrical resistance was re-measured.

Pictures and results found during transversal resistance test after 96 hours SST

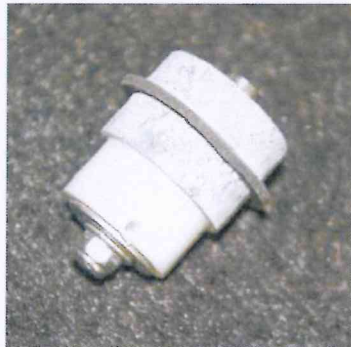
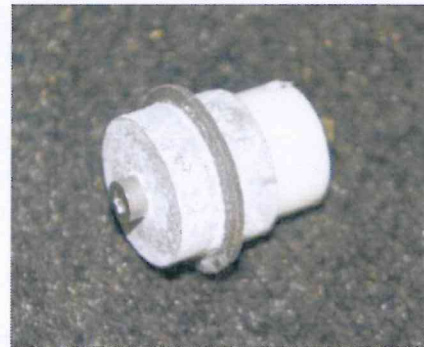
Pictures of the EUT and electrodes oxidation after 96 hours SST

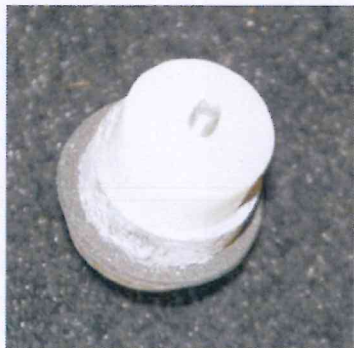
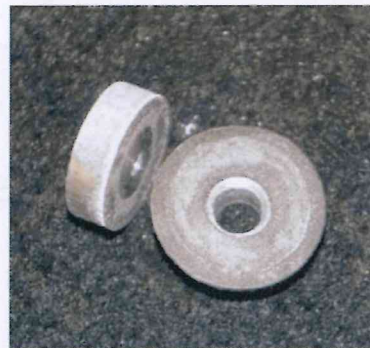
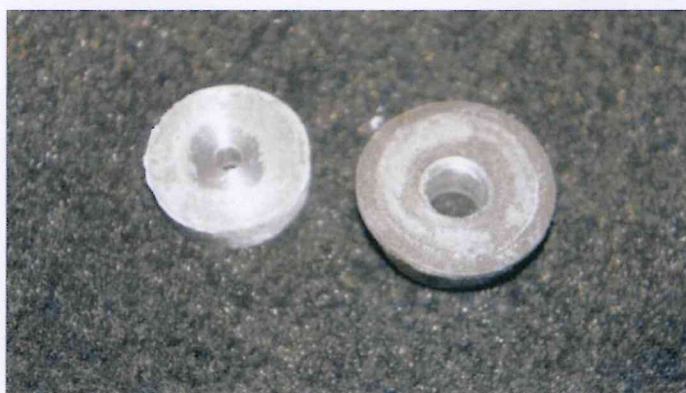
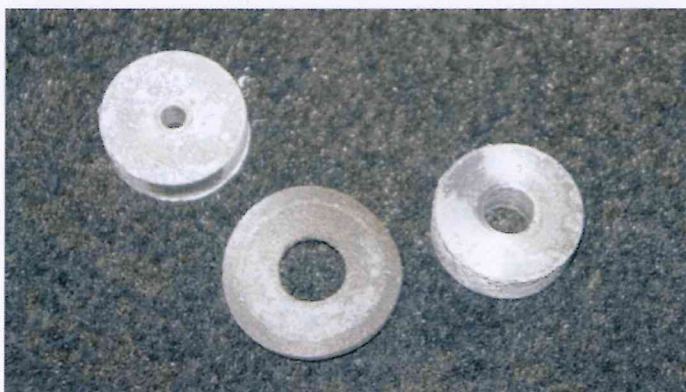
Pictures of the EUT and electrodes oxidation after 96 hours SST
